## **Inadvertent Distress Beacon Activations**

### **Executive summary**

**ORCV Special Investigations Group**

September 2022

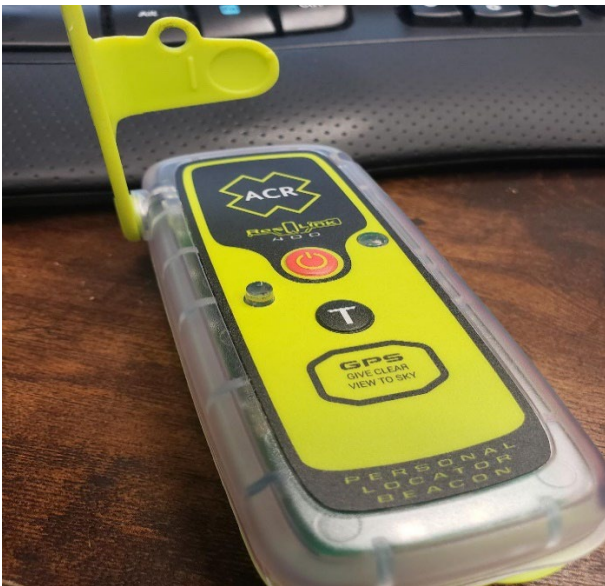
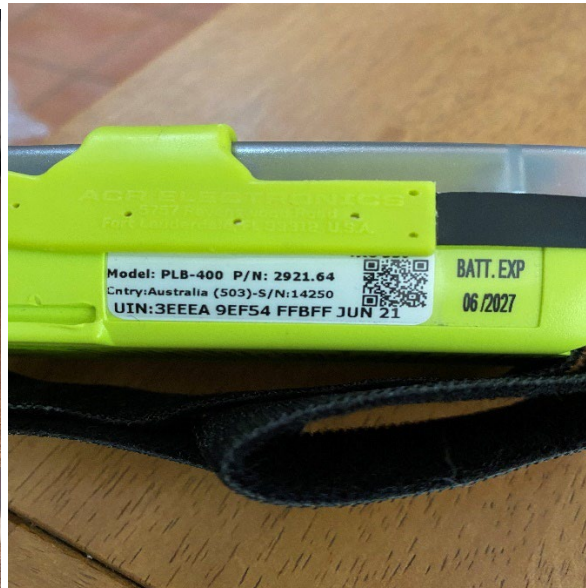
1. S/N 2535 FOR [REDACTED]
2. S/N 14250 FOR [REDACTED]

**Problem Statement:** BOTH UNITS INADVERTENT ACTIVATION DURING  
MELBOURNE TO HOBART RACE

Both units passed all test and functioned appropriately as per design.

**Conclusion:** There are no known defects associated with the units that experienced the inadvertent activations. All regulatory requirements were satisfied based upon the test conditions that were exercised at ACR. It is recommended that consumers review the user manual and understand proper operational conditions to limit the potential inadvertent operations that may be experienced with the unit ([PLB Tips Guide](#)). In addition, ACR has taken additional preventative measures that will be reflected in PLB product enhancements that limit inadvertent activations starting in 4Q2022. *See below:*

To introduce a new part to the PLB. A spacer that will be place between the front cover and the PCB in order to address inadvertent activations
