**REPORT OF AN INVESTIGATION  
INTO A MARINE CASUALTY  
INVOLVING THE SAILING YACHT  
JELLY BABY  
IN OR AROUND  
CORK HARBOUR, CO. CORK  
24 OCTOBER 2021**

**REPORT NO. MCIB/314  
(No.5 OF 2024)**

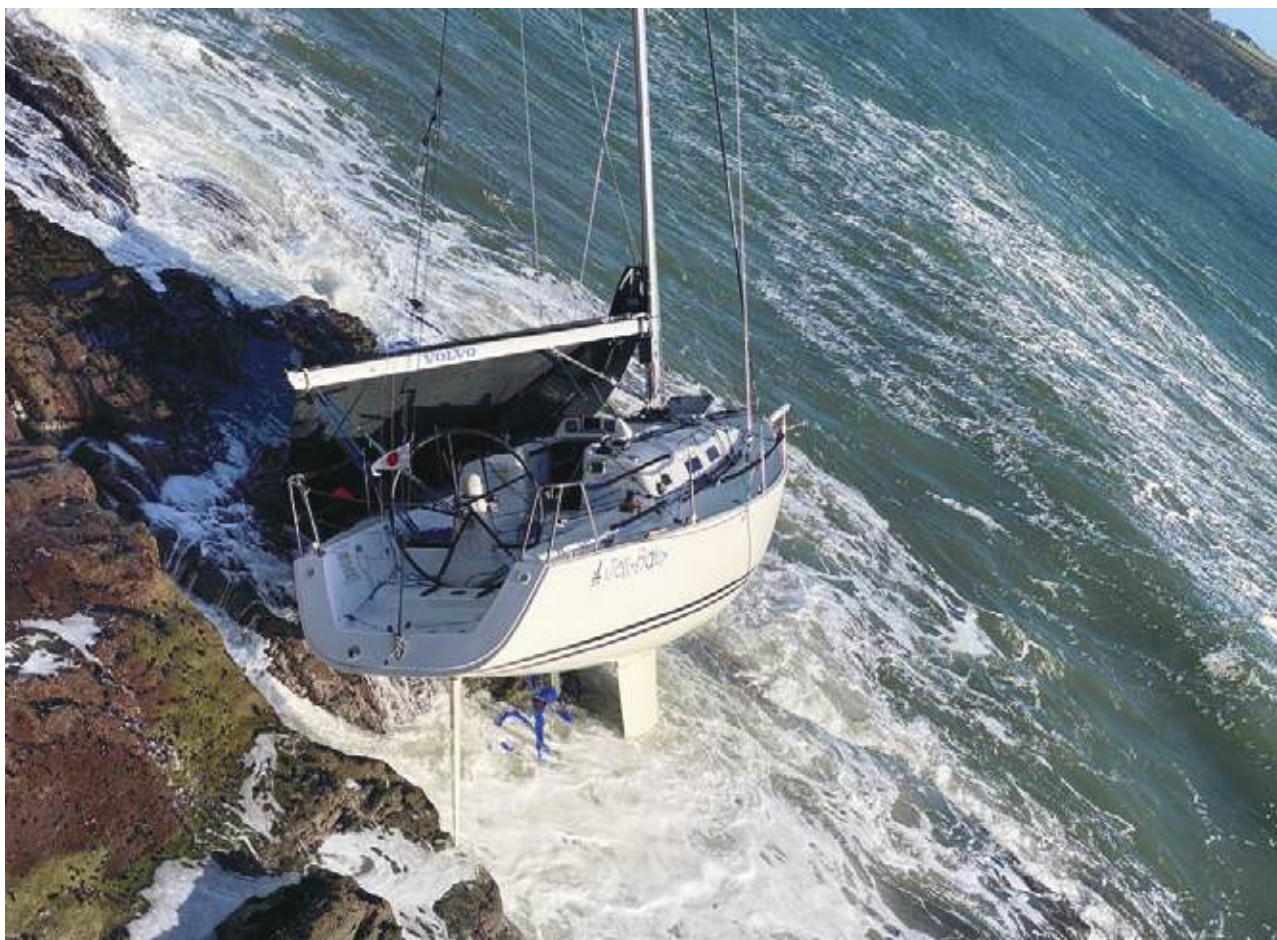
## Appendix 7.2 Yacht Jelly Baby Aground on Bull Rock, Weavers Point

- 1.3 The Bowman was successfully recovered and the crew were uninjured, but the yacht remained aground until floated on the following flood tide and was then towed to Crosshaven. The damage to the yacht was such that its insurers declared it to be a constructive loss (i.e. deemed a total loss). The yacht was repaired and the MCIB was advised it sails on Belfast Lough.

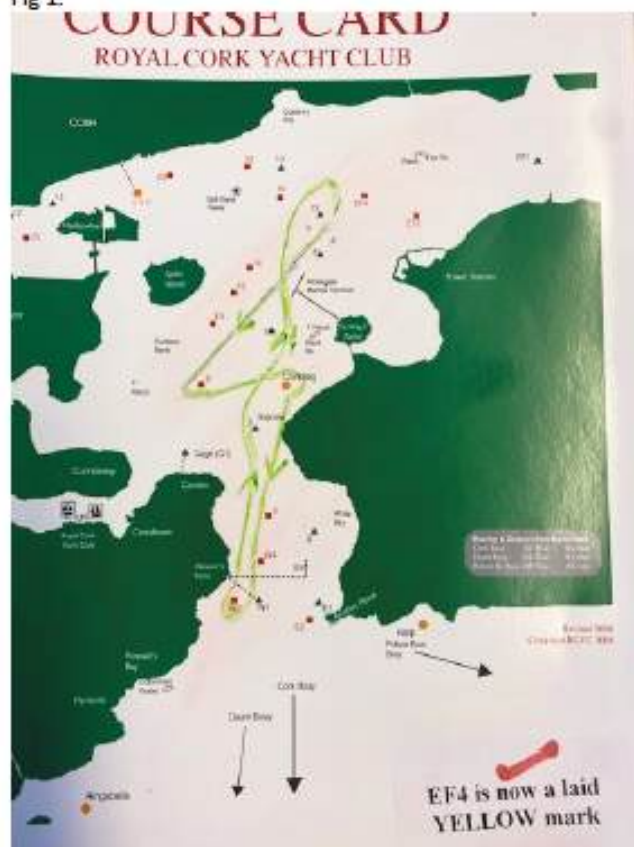
Fig 1.

Visual of the first leg of the course 24/10/2021

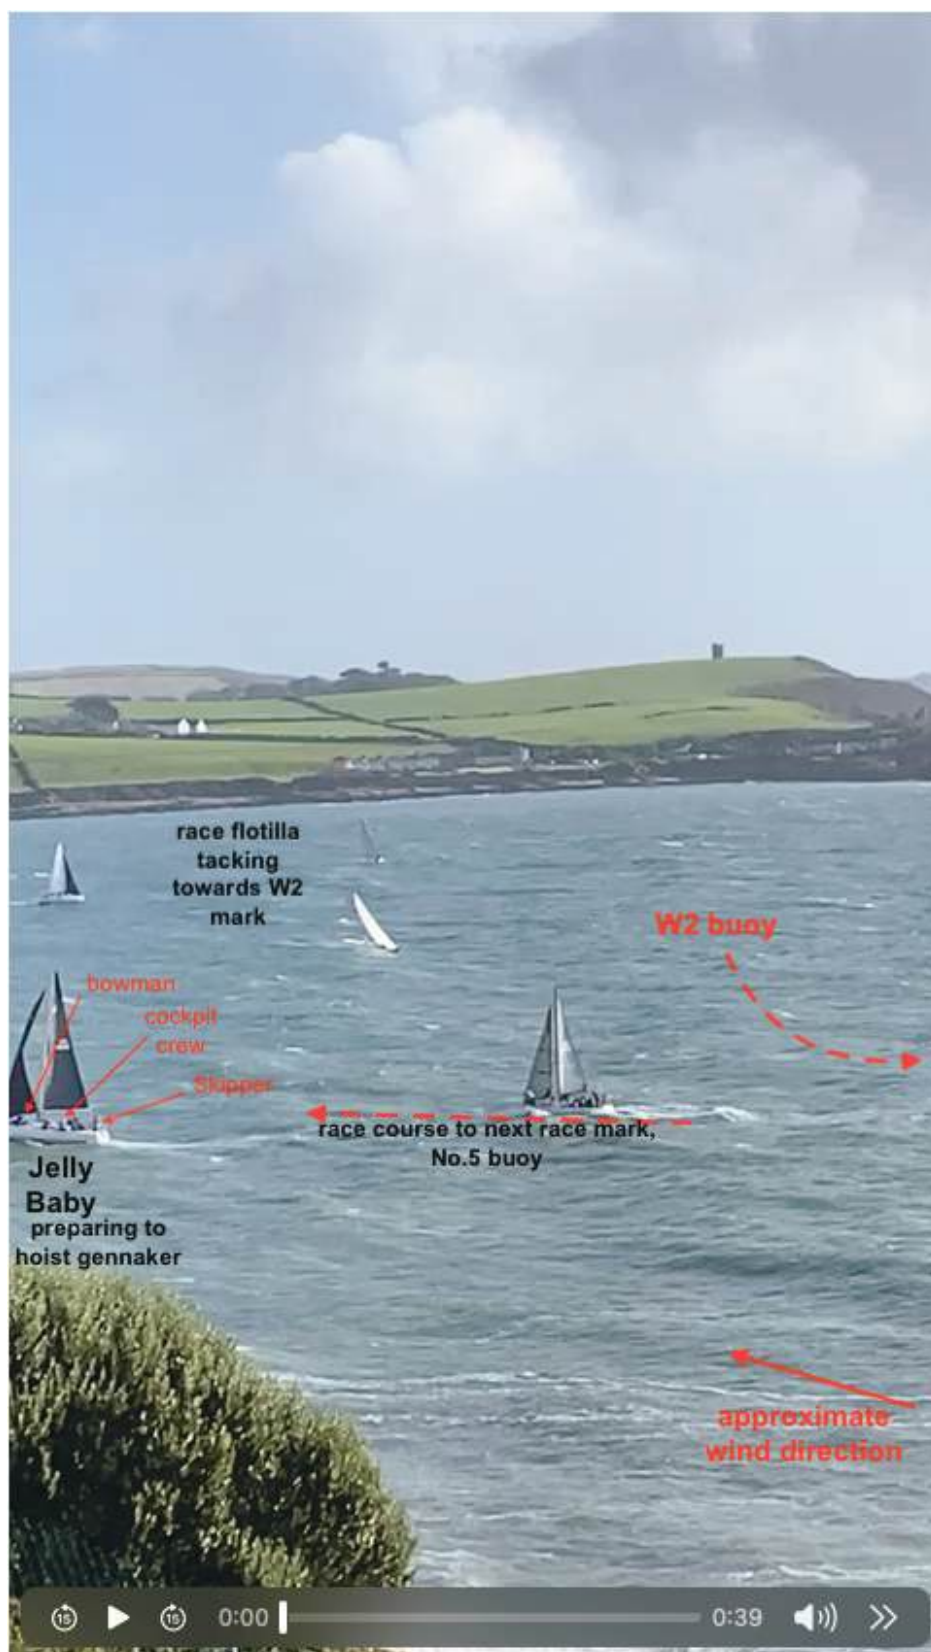
Video Still 00/39 Crew preparing to hoist gennaker.

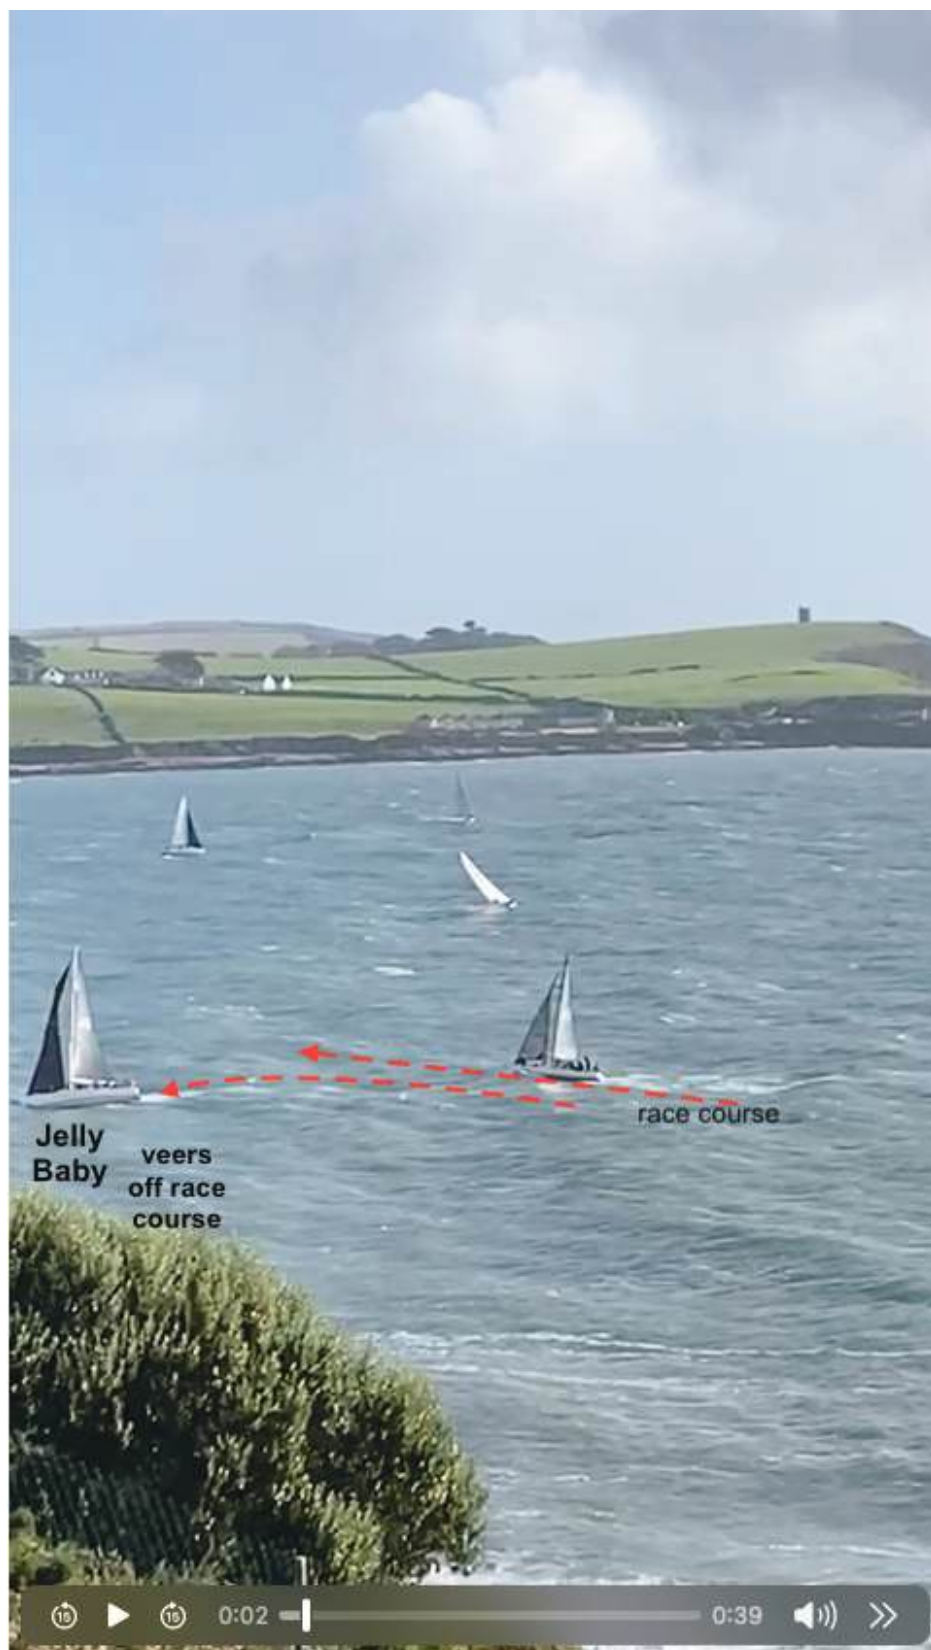
Video Still 02/39 Yacht steers off course to port.

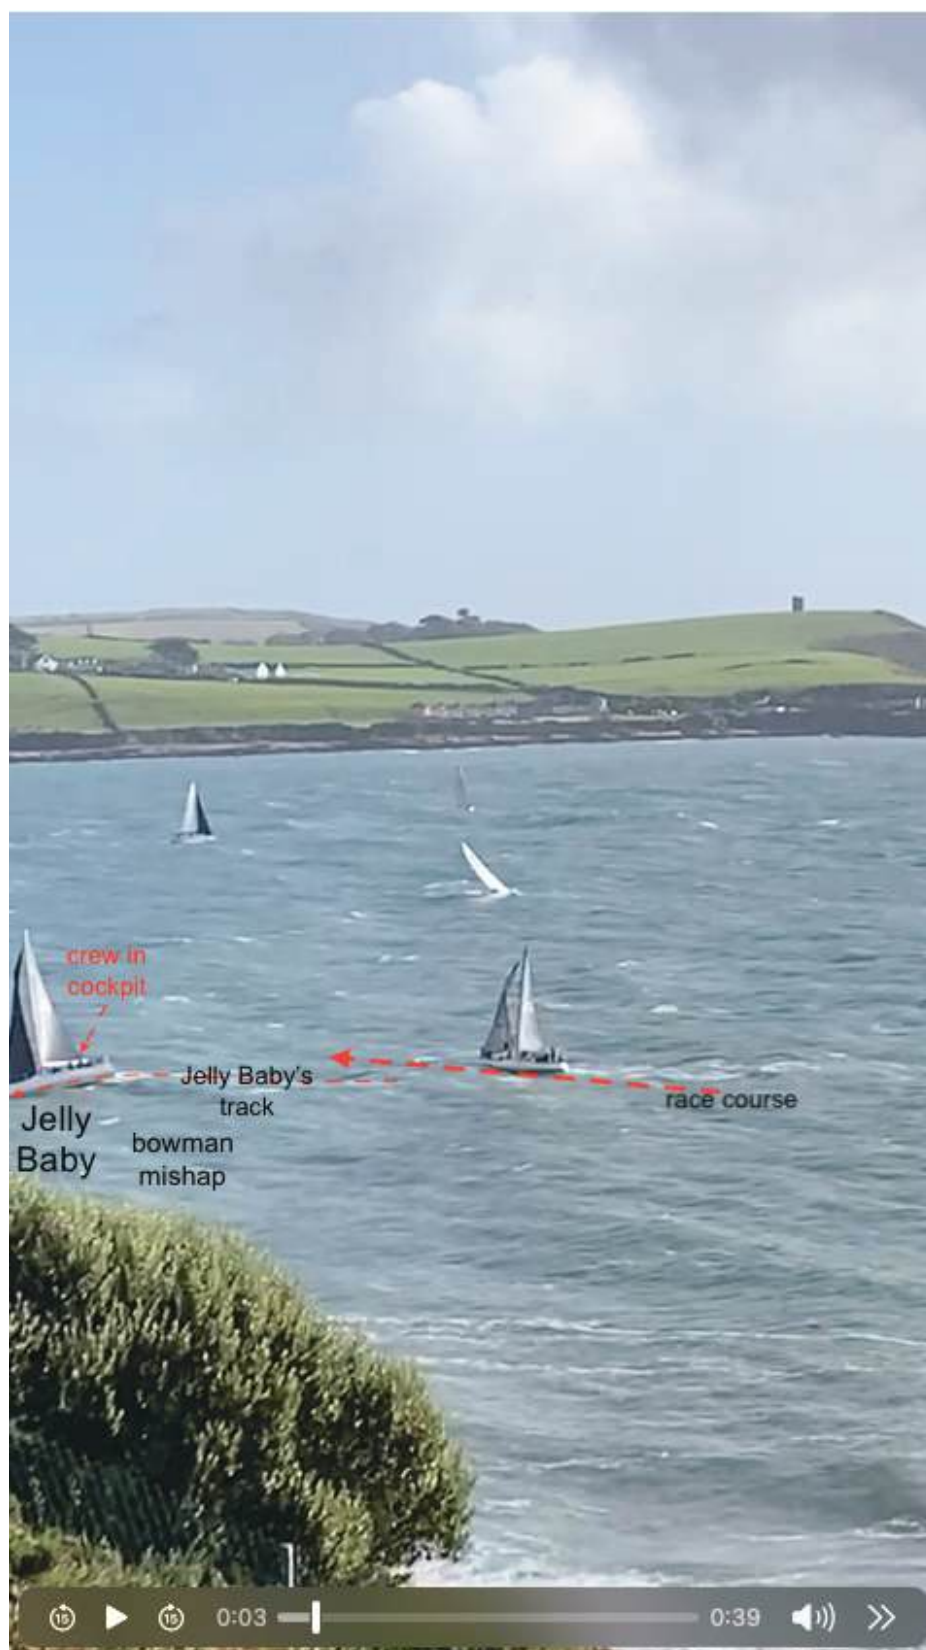
2.3.6 The MCIB learned subsequently from witnesses onboard the yacht that the Bowman clung on to the yacht's side and was never separated from the yacht. Witnesses recounted that the Bowman was quickly retrieved safely back onboard by fellow crewmembers without further mishap. However, that event combined with the gennaker going overboard led to the ultimate outcome.

Video Still 03/39 Bowman slips over the side.

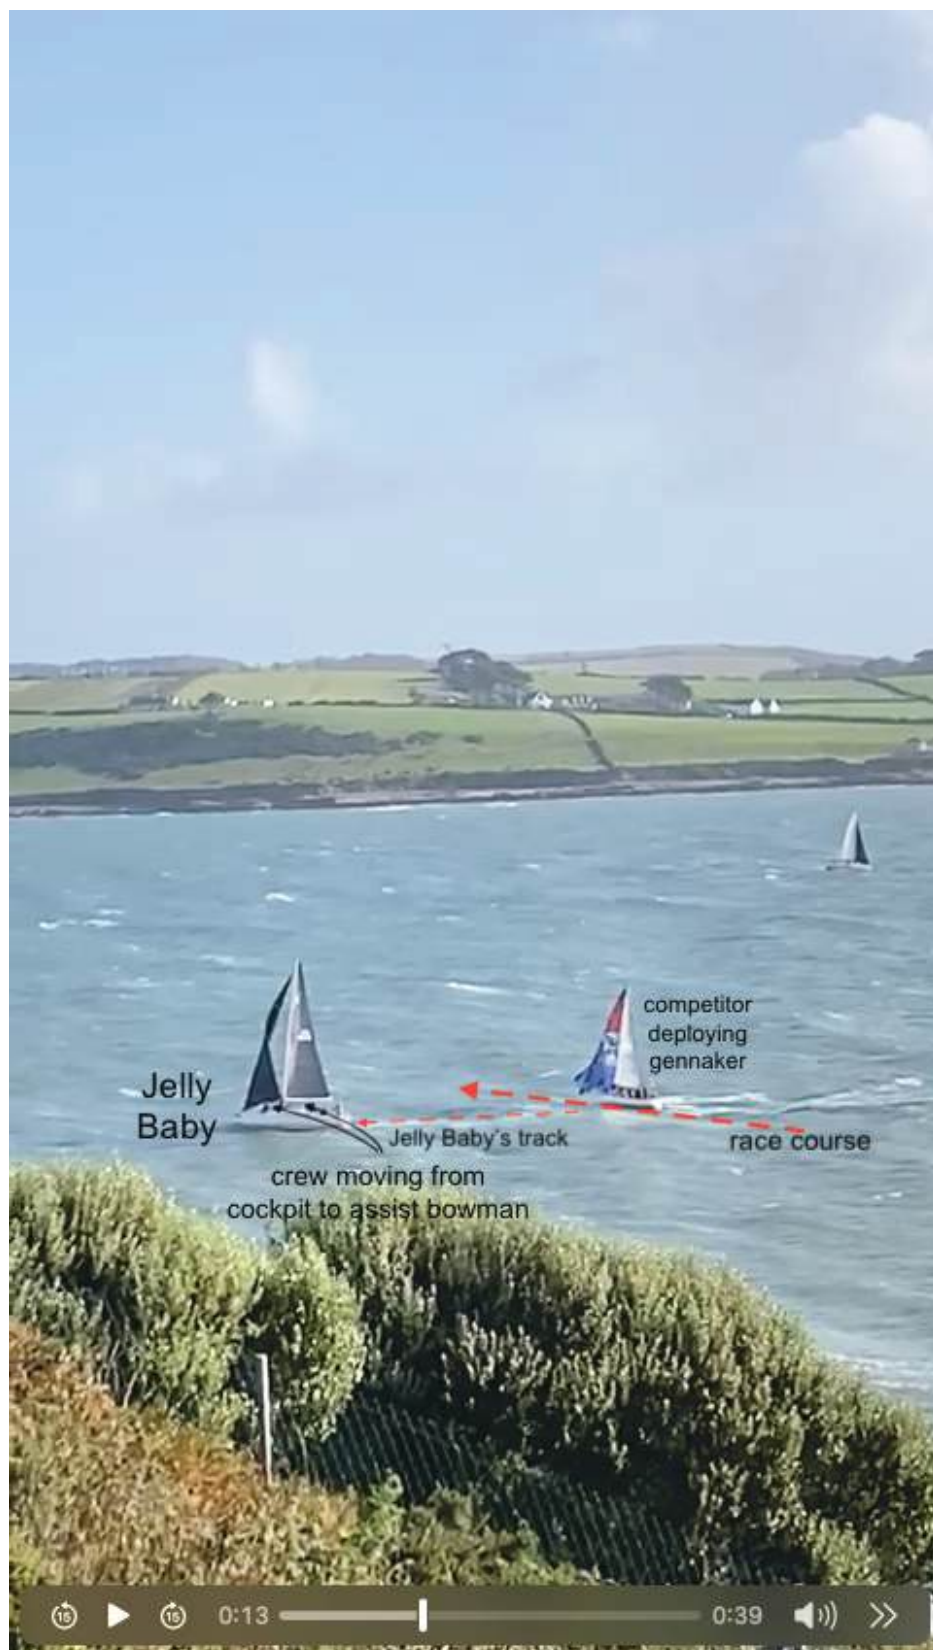
Video Still 13/39 Crew moves forward.

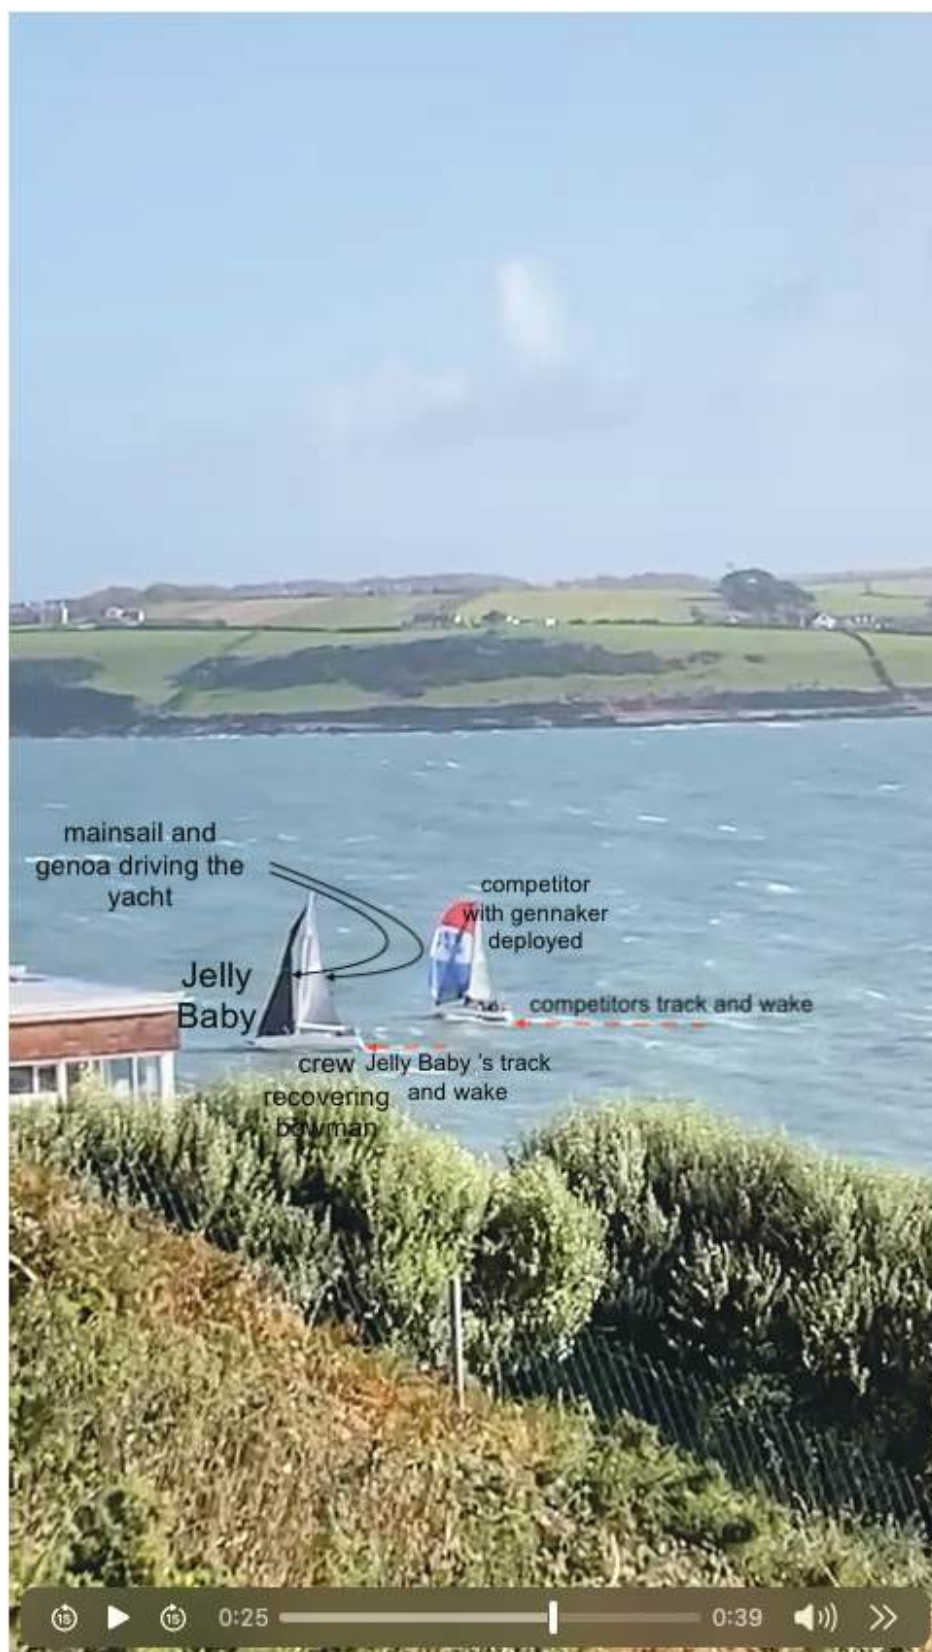
Video Still 25/39 Gennaker over the side.

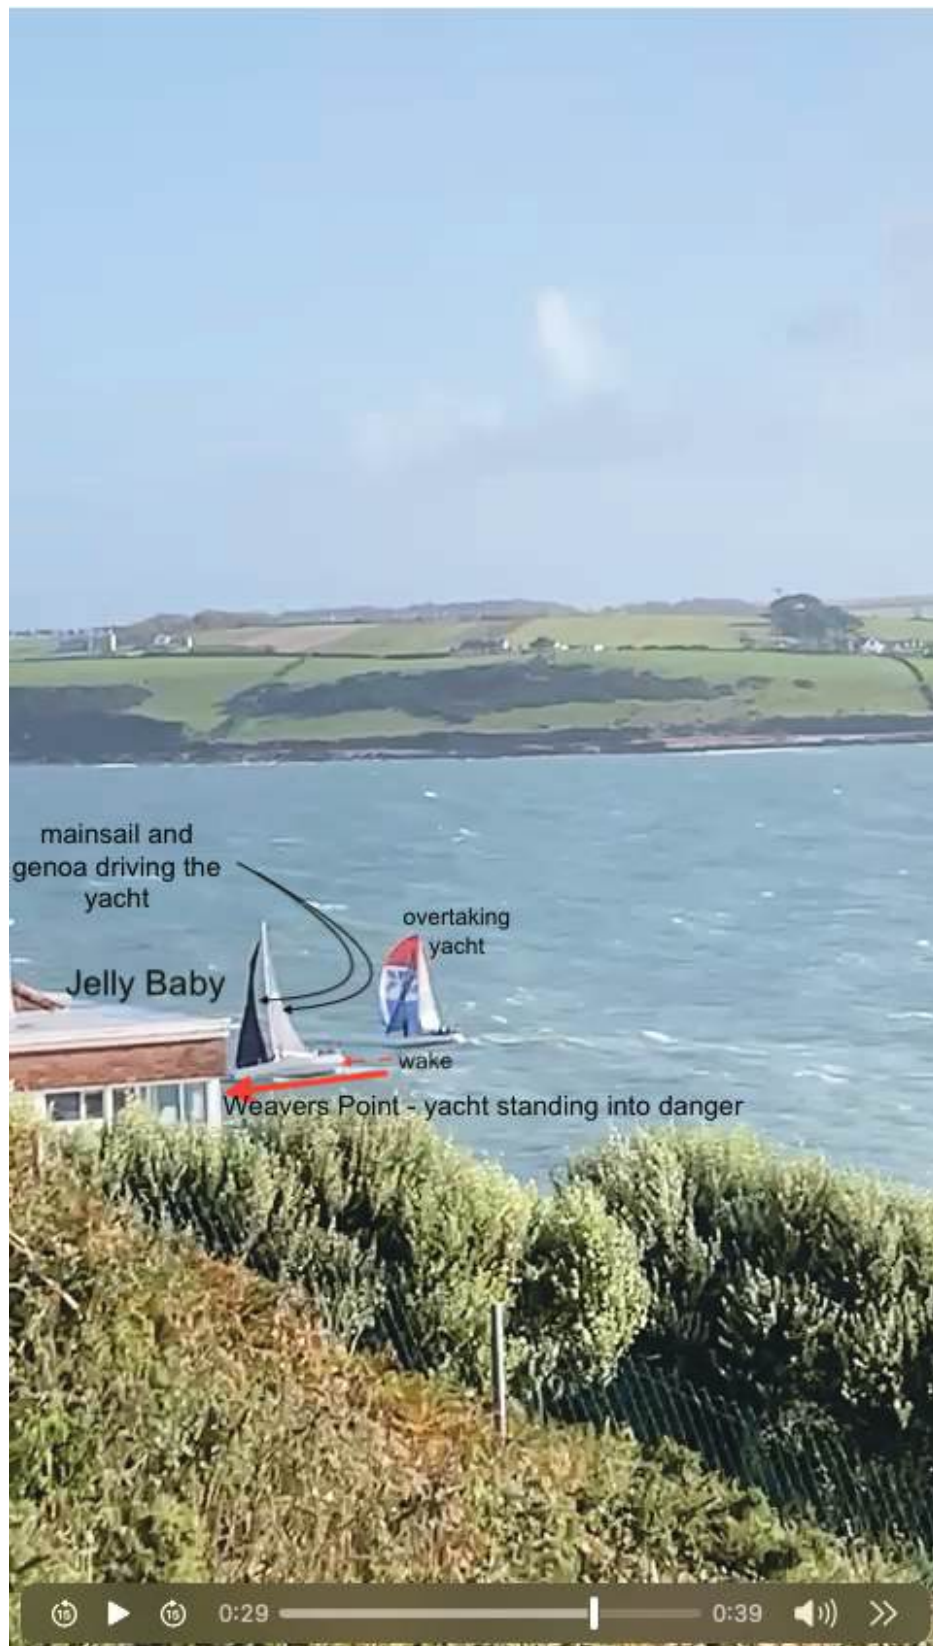
Video Still 29/39 Yacht - standing into danger.

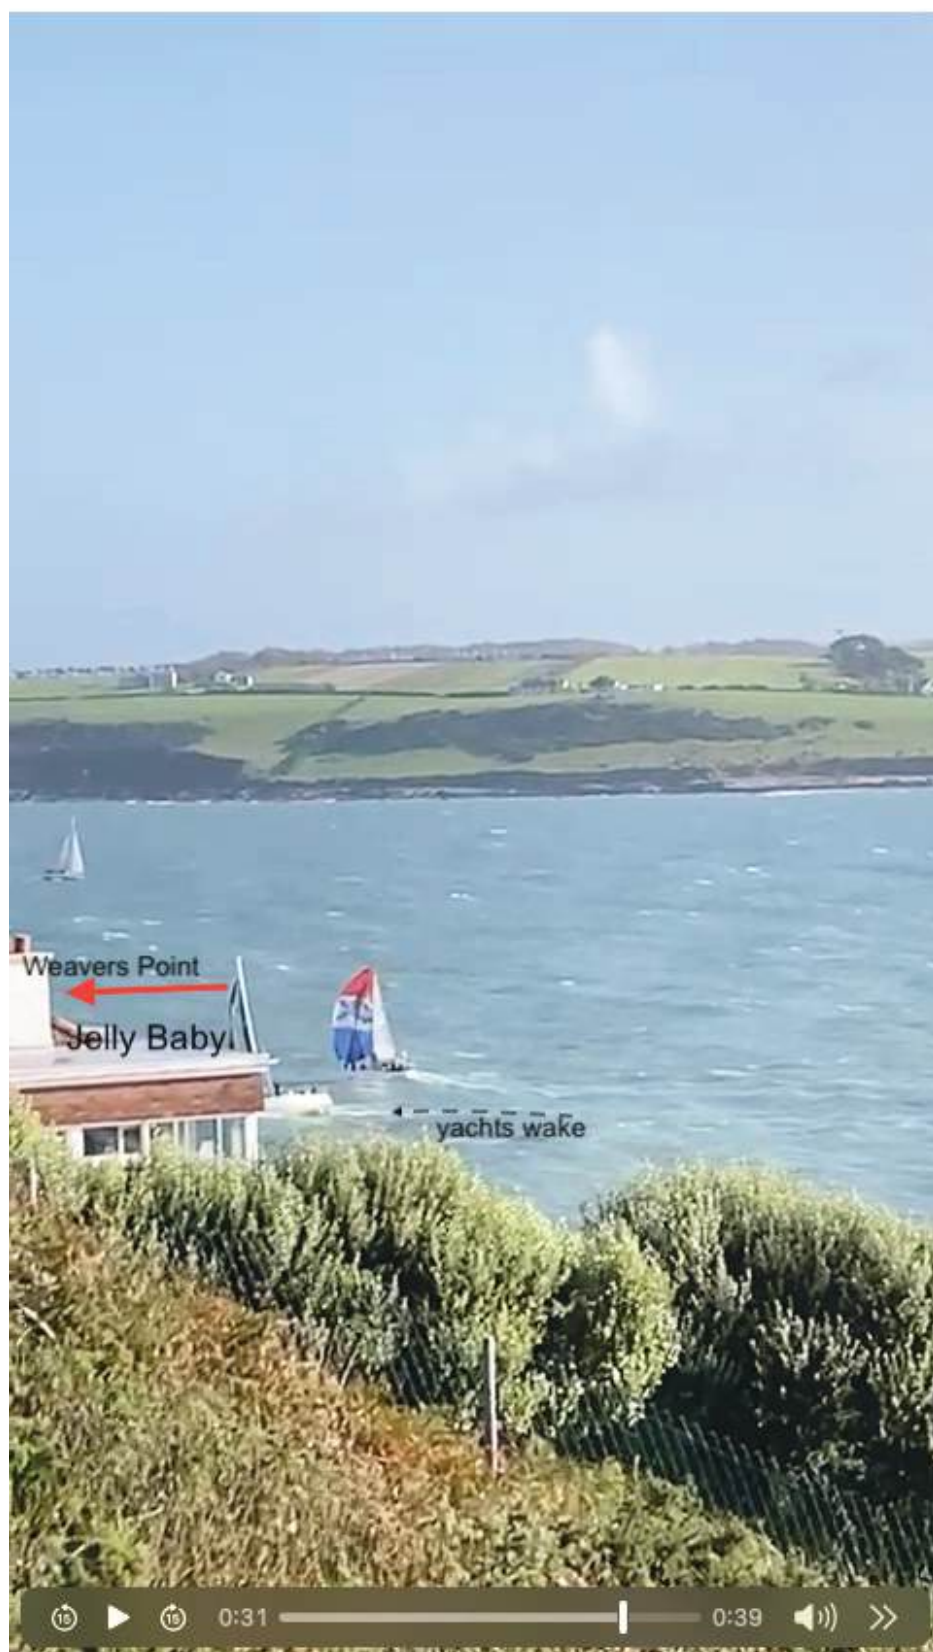
Video Still 31/39 Yacht - not under control.

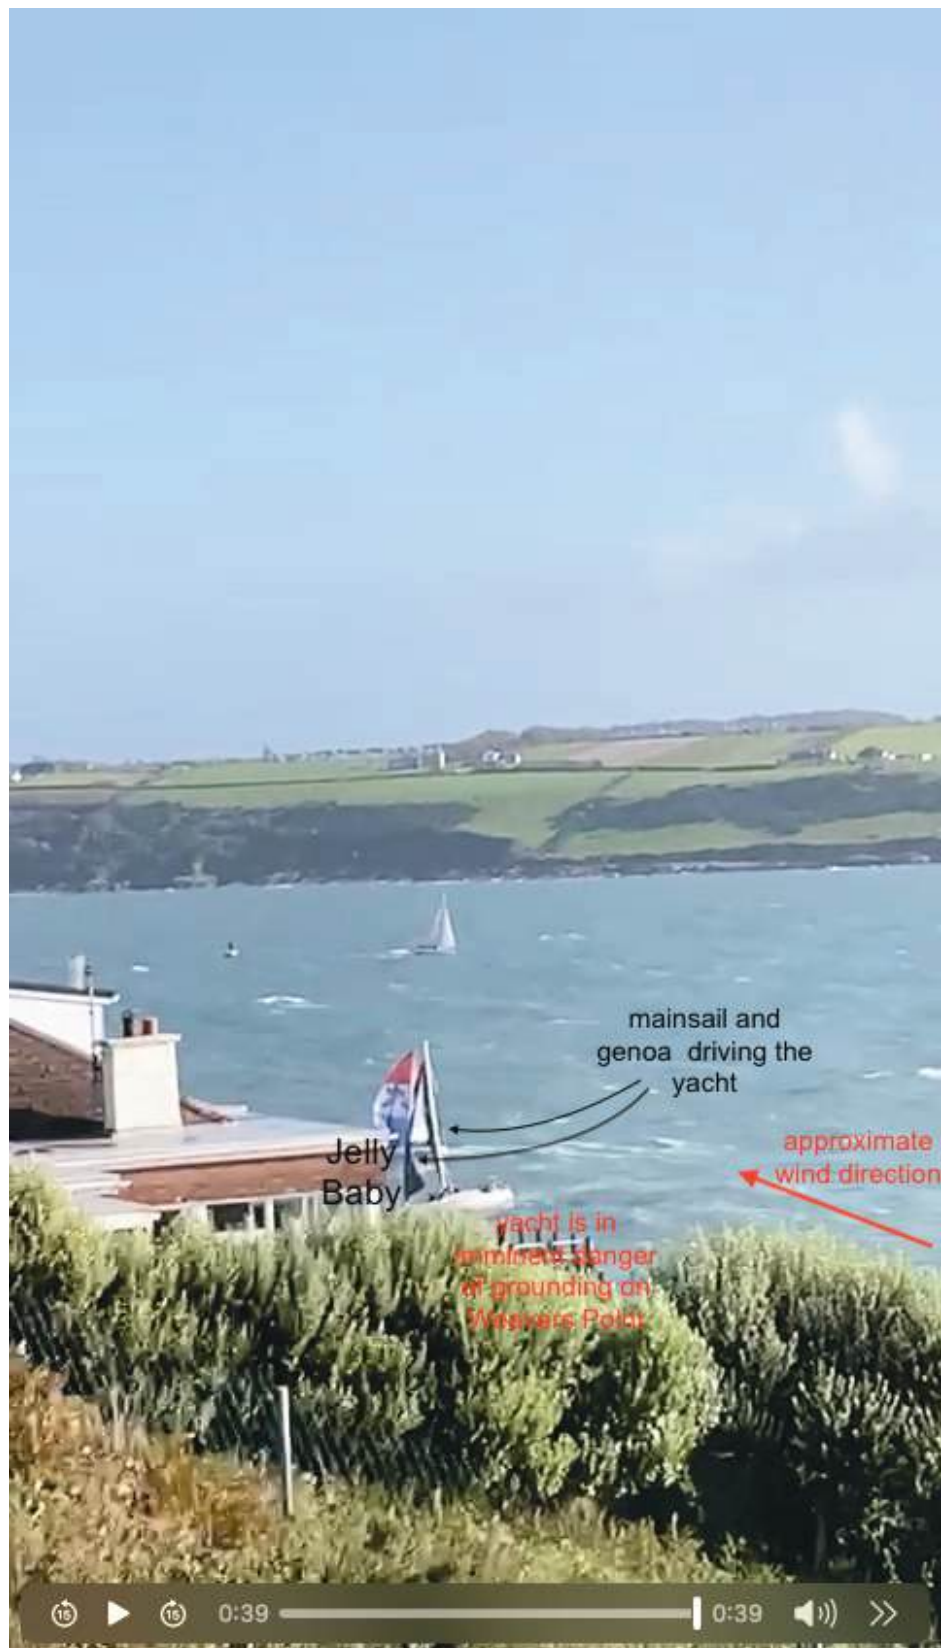
Video Still 39/39 Yacht - imminent grounding.
