## **REPORT ON THE STRUCTURAL ISSUES FOUND DURING THE 2024 NEWPORT-BERMUDA RACE, INCLUDING THE SINKINGS OF THE SAILING VESSELS *GUNGA DIN* AND *ALLIANCE***

Conducted by: James D. Phyfe, III, David Pedrick – President, Pedrick Yacht Design, Harry Dunning – Dunning and Associates, LLC, and J. Michael Keyworth

Issued: 4 May, 2025, Title modified 22 May 2025

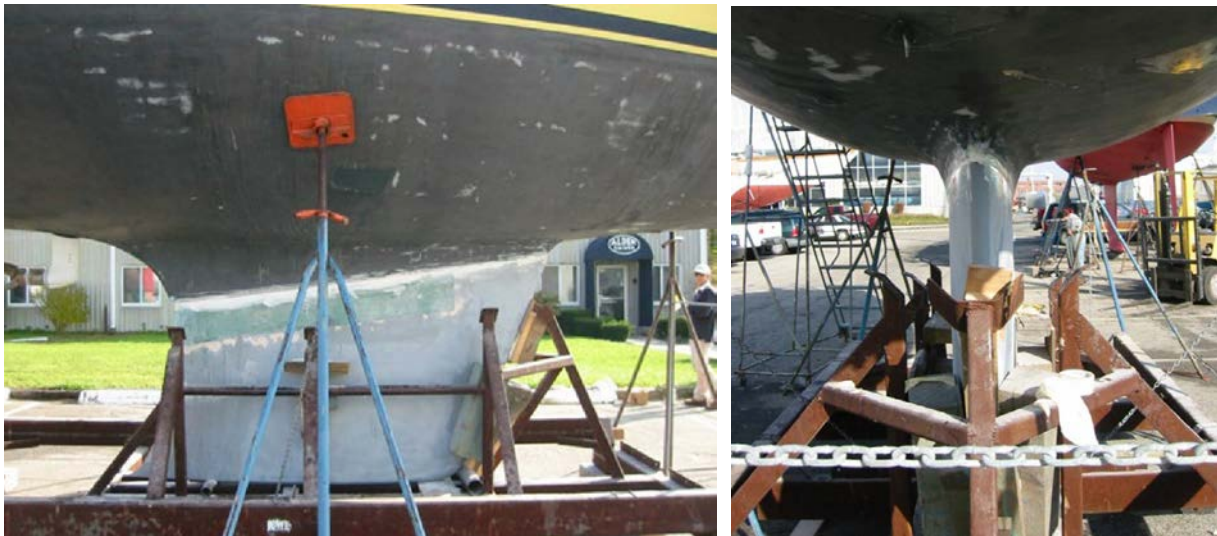
**FIGURE 4** – Note the tight fit of the replacement keel to the existing keel stub.

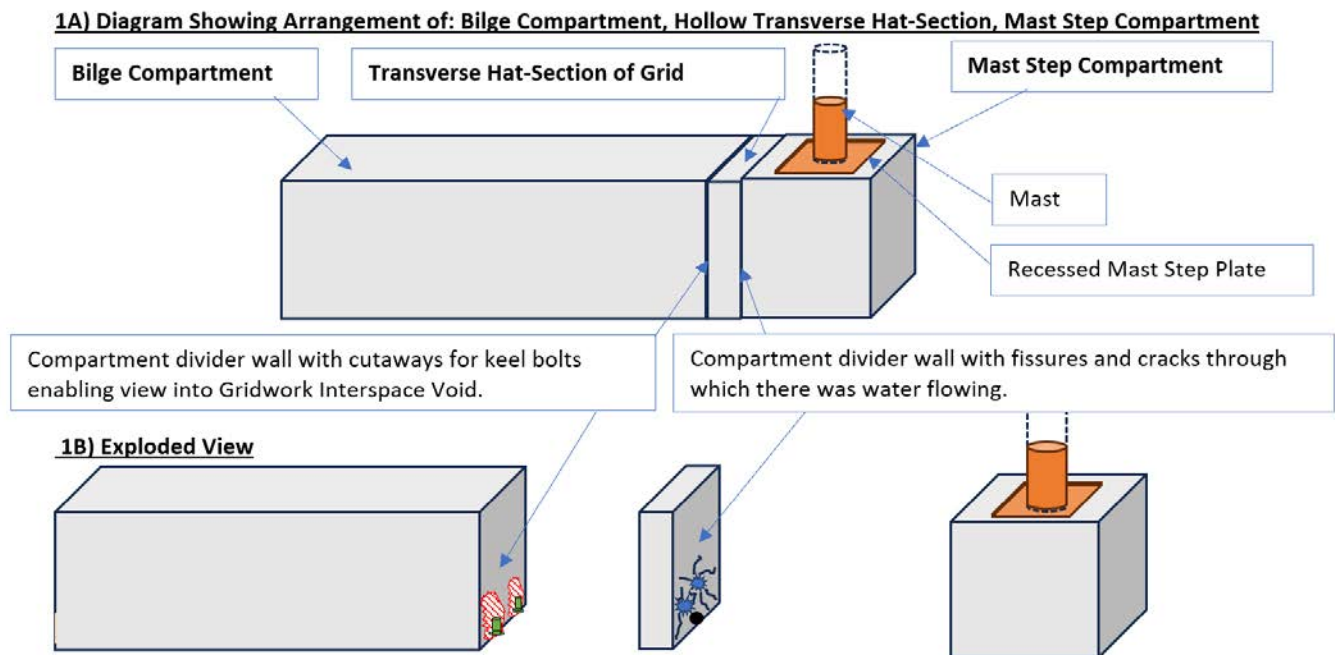
**FIGURE 6** – Dr. Alec Fye’s diagrams of the damage he observed.

Referring to Figure 6 and per Alec Fye’s notes at the top, the set of boxes portrayed in 1A represents the space under the cabin sole (floorboards) that required removal of the salon table for access. The bow is to the right in this diagram. Although the spaces are drawn with enclosed sides, what’s inside each box warrants explanation. The large, left box is the open-topped bilge bay between the inboard walls of the grid’s longitudinals. The bilge bay’s forward face is the same as the aft face of the next thin slice. The thin box represents the hollow transverse “hat-section” located at the after end of the mast step. This was part of the structural grid. The forward box represents the mast step compartment. The orange post and plate represent the mast and recessed heel plate.

The exploded view adds sketches of damage in both faces of the hollow “hat section.” However, the damage was seen from aft. Details of damage have been sketched on their respective forward faces in Figure 6. The next two sketches (figures 7 and 8) show how these two faces appeared to Alec Fye when viewed from aft.

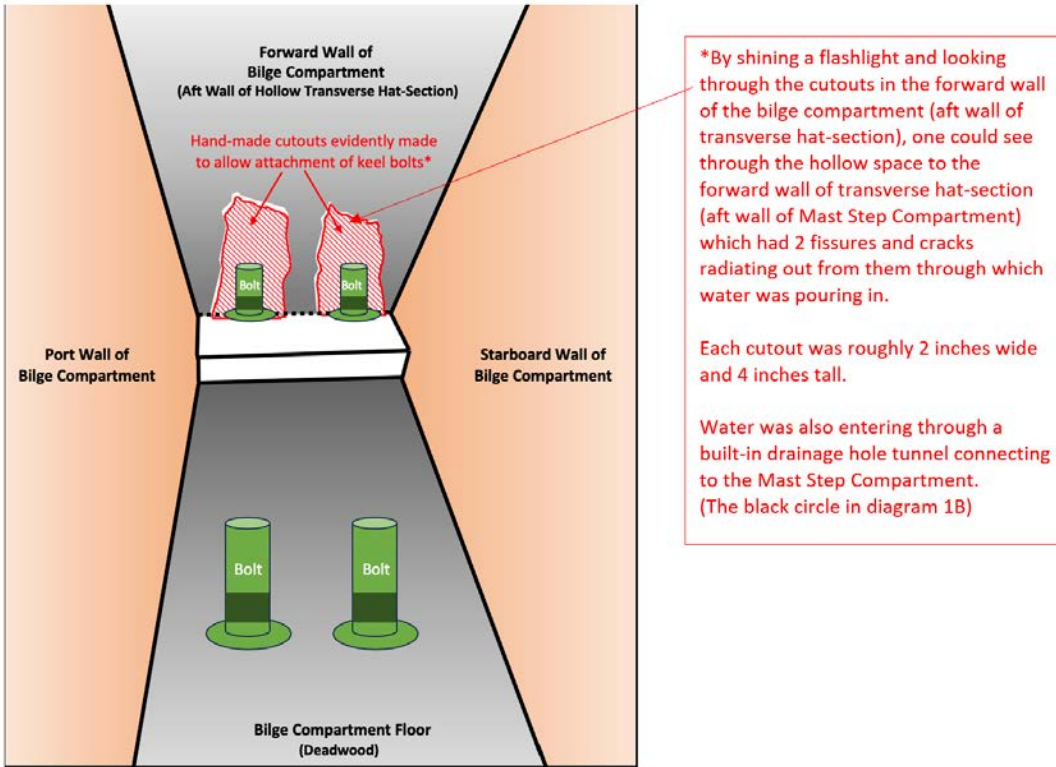
At this point, it is important to take note of modifications to the hull grid made by an unknown party at an unknown date. When Alec Fye looked forward from the open topped bilge bay (left box), he observed two jagged, crudely-cut holes in the aft face of the “hat-section” separating the open bilge bay from the mast step compartment. These holes, which may have been cut with a reciprocating saw around the time of the keel replacement, appear to have been made for the purpose of accessing the forwardmost pair of keel bolts. Alec Fye describes them each being approximately the size of a deck of cards. It was through these two holes that he could see the water streaming through a “spiderweb” of cracks in the forward face of the “hat-section.”

It is a little unclear how these holes came to be, but it is possible that, although the new keel was designed to fit the existing bolt pattern, the forwardmost pair of bolts on the new keel were slightly forward of the old ones. Hence, the need to gain better access. It is equally possible they were made at some other time. Either way, these two jagged, irregular cutouts in a key structural member supporting the mast step most likely weakened it significantly – certainly compromising the designed strength and purpose of this key part of the structure.

FIGURE 7 – Dr. Alec Fye’s diagrams of the damage he observed.

3) View Looking Forward Through One of the Cutaways into Gridwork Interspace Void to see Aftmost Wall of the Mast Step Compartment which had Two Fissures & Cracks Radiating Outward Through which Water was Entering

Interspace Gridwork Void roughly 6 inches deep, 12 inches across, and 12 inches tall

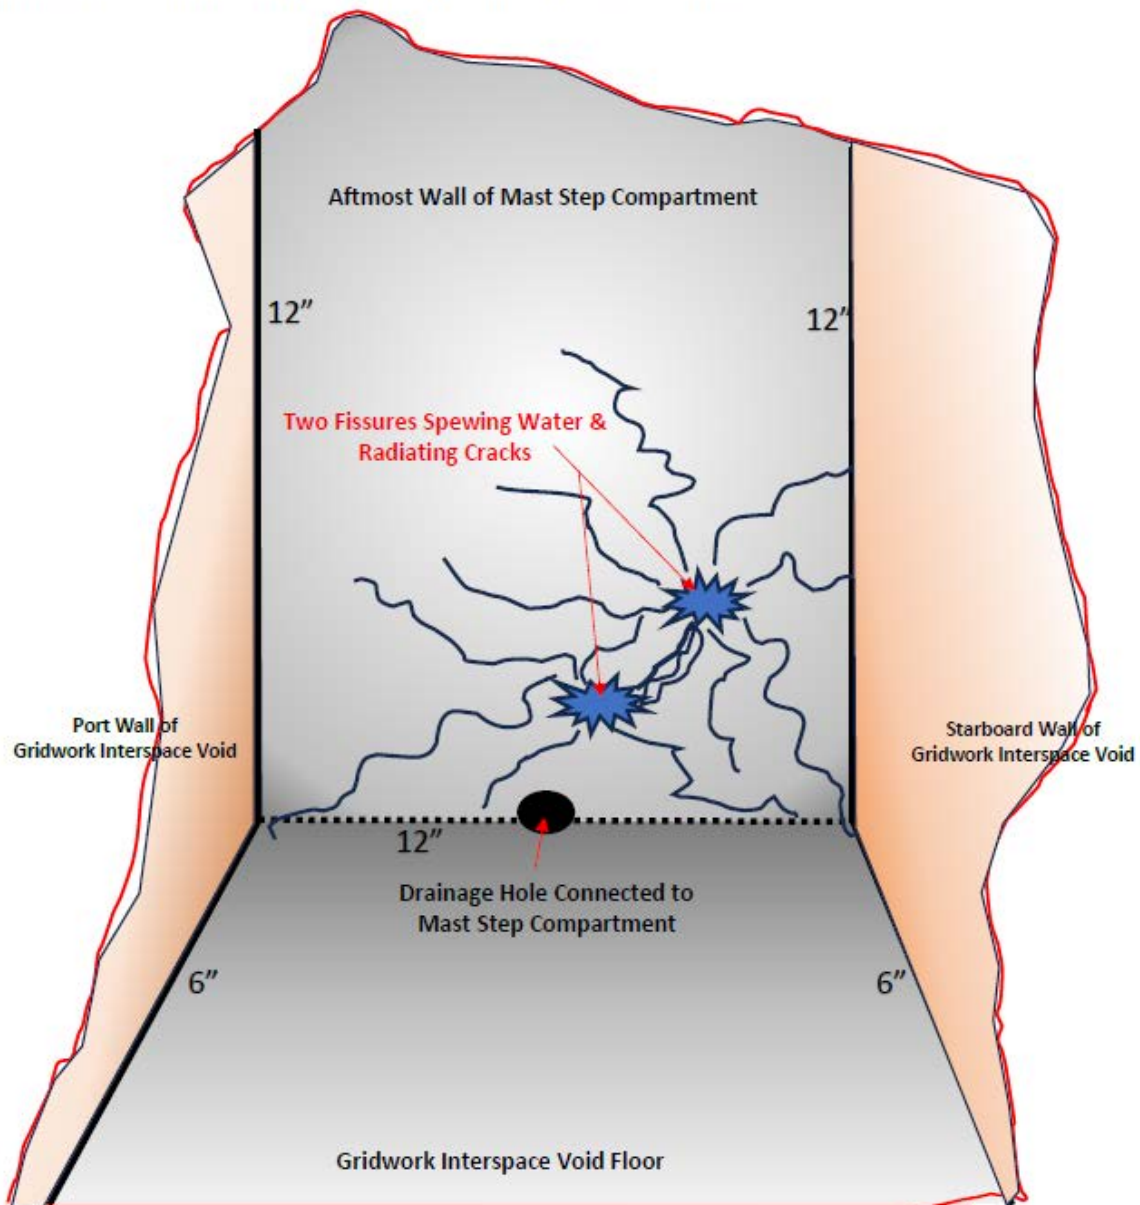
**FIGURE 8** – Dr. Alec Fye’s diagrams of the cracks he observed through which water was flowing. Note that water was also seen running aft through the pictured limber hole.

How did this spiderweb of cracks in the forward face of the “hat section” develop and what were its implications? As noted, this transverse member of the hull grid was directly aft of

the mast step and in the area of the forwardmost pair of keel bolts. Although it cannot be said with certainty, the conditions leading to the formation of these cracks most likely have roots to the decision to cut crude access holes to better access the forwardmost pair of bolts.

The structural consequence of this is such that the nuts and washers on the forward keel bolts put very high downward stress into the immediate fiberglass hull. This can result in delamination fractures within the thickness of the fiberglass shell at the keel bolt holes, compression of the fiberglass and cracking in the resin. Additionally, the already weakened structure of the mast floor web provided diminished resistance to athwartships bending in the bottom of the keel stub from the surge in keel bolt tension. This causes permanent damage. Therefore, the combined effects of the modified hull framing grid structure exacerbated by the impact of two known groundings most likely weakened the area beneath the mast step to a degree that three days of heavy upwind pounding into steep, confused seas caused the mast to "jackhammer" its way into the weakened structure, ultimately causing catastrophic flooding. This process was apparent in hindsight in the gradual but visible loosening of the headstay, inner forestay and backstays that the crew observed, which indicated that the mast was being pushed down into the hull relative to the hull's chainplate foundations.

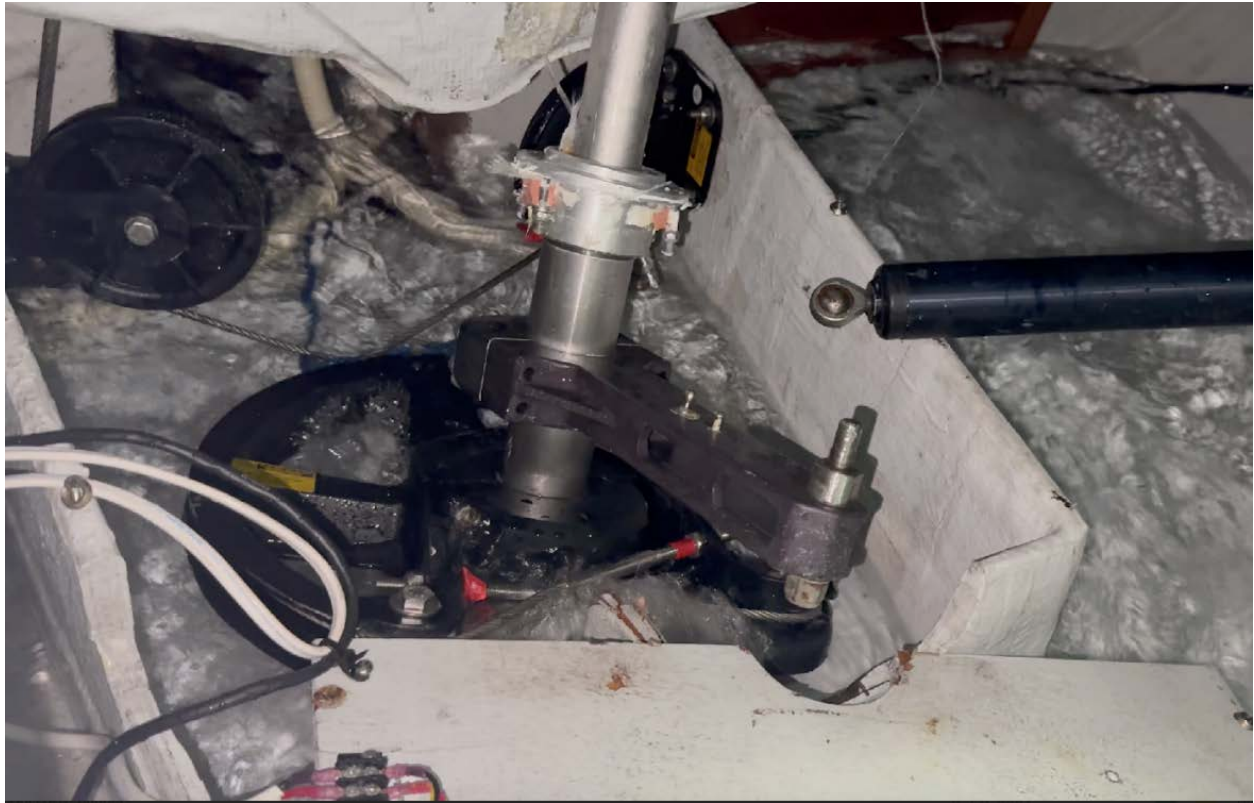
**Figure 1** This picture, taken approximately 40 minutes after the incident, shows the damage and flooding to Alliance. The upper rudder bearing is visible mid-picture above the autopilot tiller arm, having slid down the rudder stock from its original position in the cockpit sole.

It is known that the incident caused the upper rudder bearing to tear away from the cockpit sole where it was mounted and slide down the rudder shaft. At about the same time, movement of the rudder stock rotated the lower bearing housing and opened up a hole in the hull just ahead of it.

Figure 1 above shows that the upper bearing was intact when it slid down the rudder shaft and the mounting bolts remained in place. There is evidence of fiberglass and compound still attached to the mounting bolts, which could explain the burning smell Irwin and others noted immediately after the incident. It is likely the force required to unseat the bearing and the violence with which it became dislodged created tremendous heat in the surrounding structure, causing the “fiberglass burning” odor.

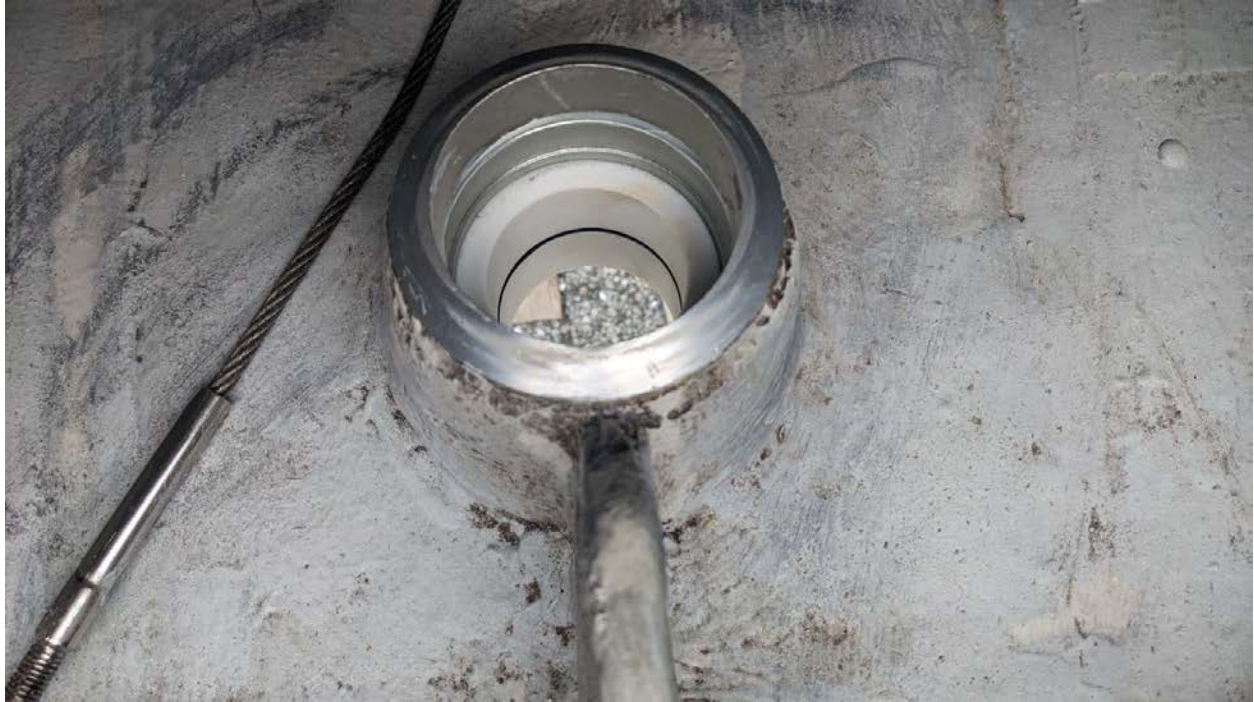
The lower rudder bearing was a self-aligning JP3 bearing manufactured in France. As previously mentioned, it had been replaced by a boat yard during the winter of 2023-4. Interviews with the technician who conducted the replacement did not indicate anything out of the ordinary was discovered during the process.

**Figure 3** A photograph of the lower bearing on *Alliance* and its fiberglass and aluminum housing. This picture is taken from aft looking forward. Note the longitudinal support immediately aft of the structure.

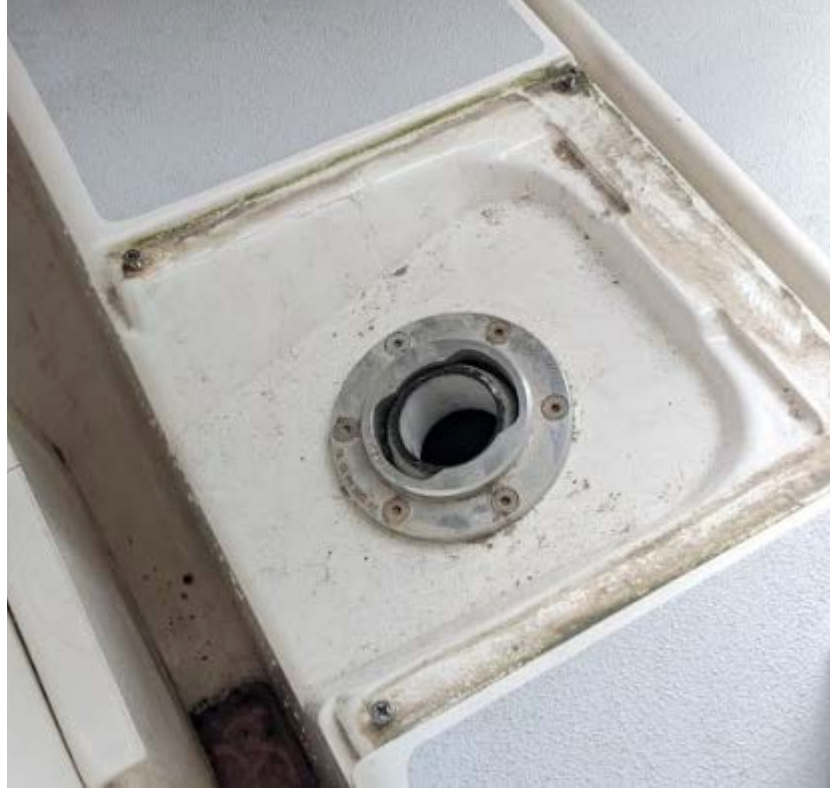
**Figure 4** The upper rudder bearing aboard *Alliance* when viewed from on deck. Note that the bearing is located immediately aft of the wheel well (visible) in the cockpit sole and is normally covered by a removable fiberglass plate.

As previously discussed, the upper rudder bearing on *Alliance* was flush mounted in a composite panel and secured by six through-bolted fasteners (“mounting bolts”). The opening in which the bearing was mounted was slightly larger than the outside diameter of the external vertical face of the bearing, such that when the fasteners were removed to re-bed the bearing in the spring of 2024, the bearing could be moved fore and aft and athwartships by “about 4 to 5 mm” according to Kneller. We have found that this is a common practice among vessels of similar vintage across a number of manufacturers. The result is that the horizontal forces exerted on the bearing are supported solely by bedding compound (if any) and the mounting bolts and not the deck structure surrounding it.

According to representatives of PYI, the US distributor for JEFA rudder bearings, the upper bearing mounting bolts are not designed or engineered to support the significant horizontal loads imposed by the forces of a deep rudder maneuvering in a large seaway.

Therefore, PYI recommends that the bearings be tightly fitted within the supporting structure such that the loads may be spread across a greater framework of support. Because the mounting bolts are not designed to support the lateral loads, they may loosen or fail altogether, leading to a loss of rudder support at the upper bearing.

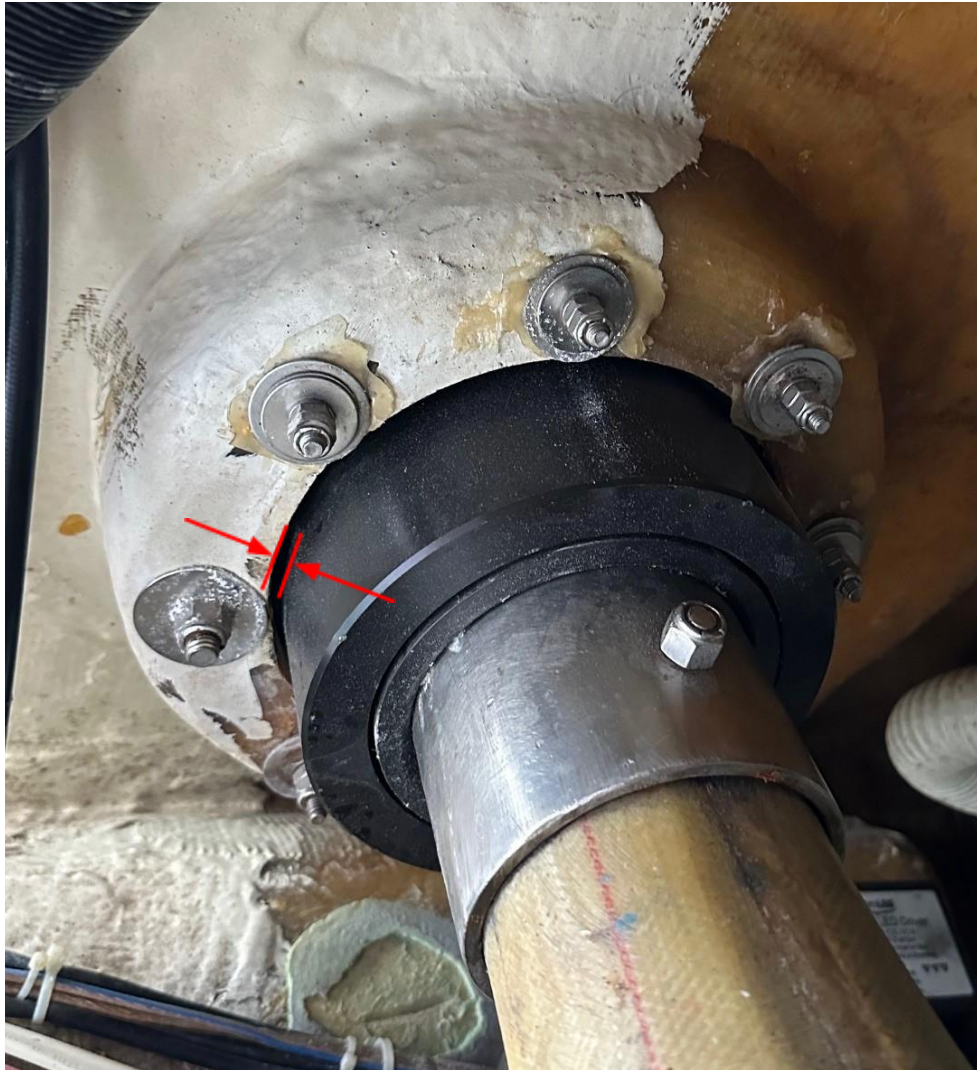
**Figure 5** A loose-fitted upper rudder bearing (vessel type not specified). Note the gap between the external face of the bearing and the structure in which it is mounted. In this case, all lateral loads are dependent on the through-bolted fasteners.

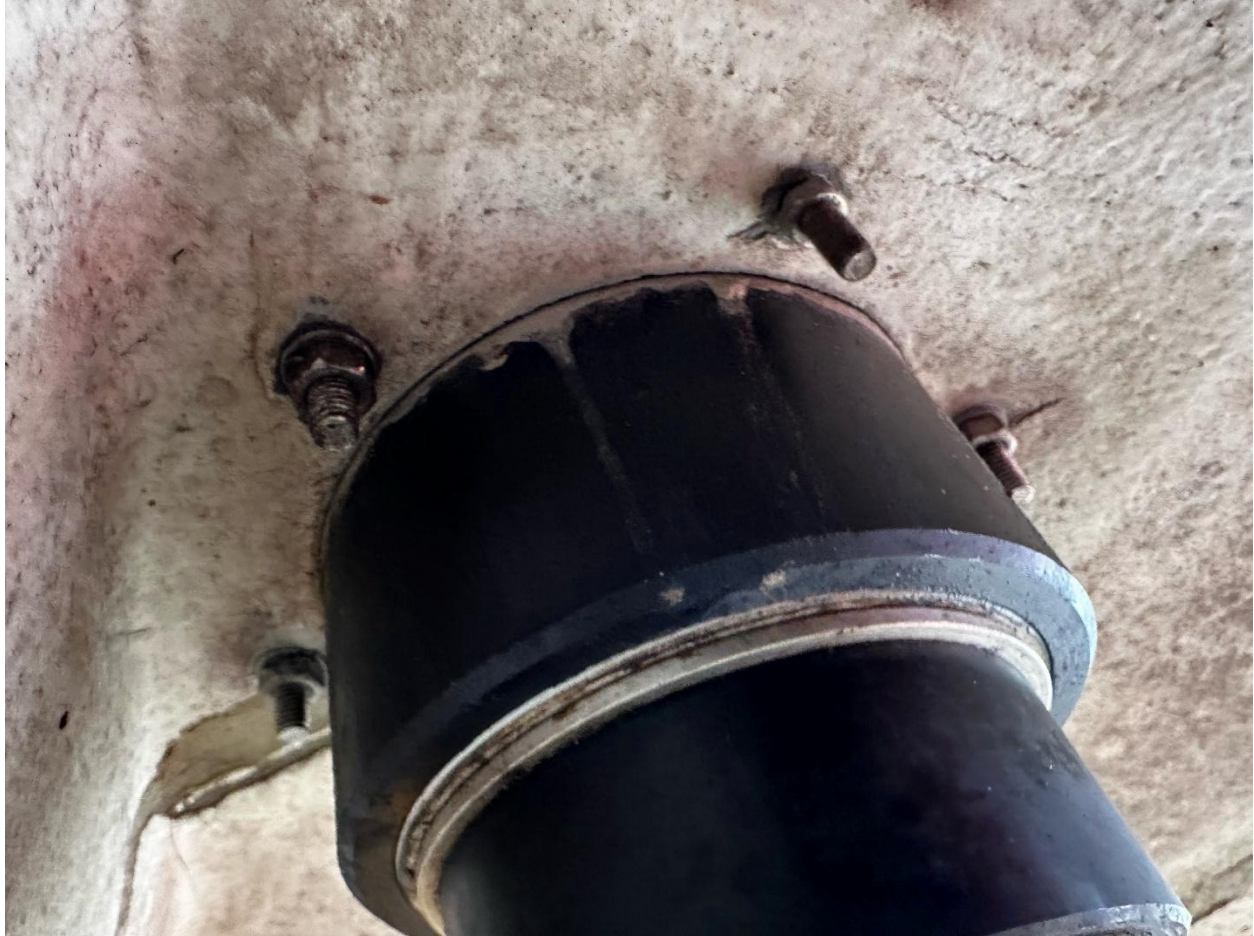
**Figure 6** Photo supplied by PYI, Inc., of a properly fitted upper rudder bearing (vessel type not specified). Note the tight tolerance between the outside of the bearing and the surrounding deck structure.

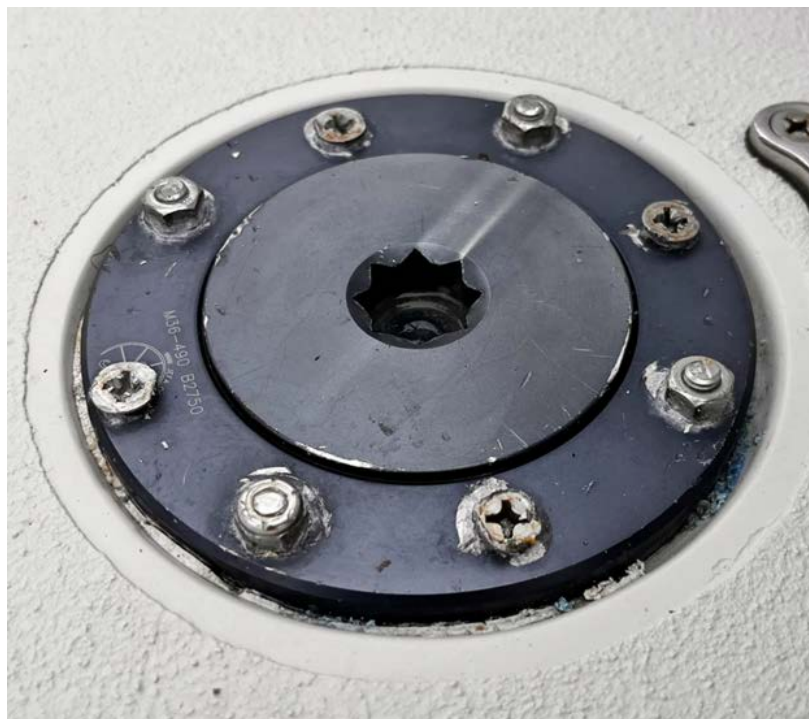
As previously discussed, we identified two other vessels in the 2024 Newport Bermuda Race that encountered issues related to the upper rudder bearing losing support. During the morning of June 23<sup>rd</sup>, shortly after rescuing the crew of *Alliance*, the crew aboard the *J/121 Ceilidh* noticed movement in the flange of the top bearing manufactured by Jefa (note

that, similar to *Alliance*, the top bearing of *Ceilidh* is mounted in the cockpit sole aft of the helm). The top bearing on *Ceilidh* was secured by four throughbolts with lock washers on the underside. When a crewmember went to tighten the throughbolts, he found two of the four had sheared completely at their heads. The crew located two similar bolts in the ship's spares, but less than an hour after replacing them, they noticed the flange moving again. Fearing the remaining bolts would also shear, the crew drilled four additional holes in the flange and into the solid fiberglass panel below it, which they used to add an additional four large self-tapping screws. This arrested any further movement of the flange and held until they arrived in Bermuda.

**Figure 9** The repaired bearing aboard *Ceilidh*.
