## **REPORT ON THE STRUCTURAL ISSUES FOUND DURING THE 2024 NEWPORT-BERMUDA RACE, INCLUDING THE SINKINGS OF THE SAILING VESSELS *GUNGA DIN* AND *ALLIANCE***

Conducted by: James D. Phyfe, III, David Pedrick – President, Pedrick Yacht Design, Harry Dunning – Dunning and Associates, LLC, and J. Michael Keyworth

Issued: 4 May, 2025, Title modified 22 May 2025

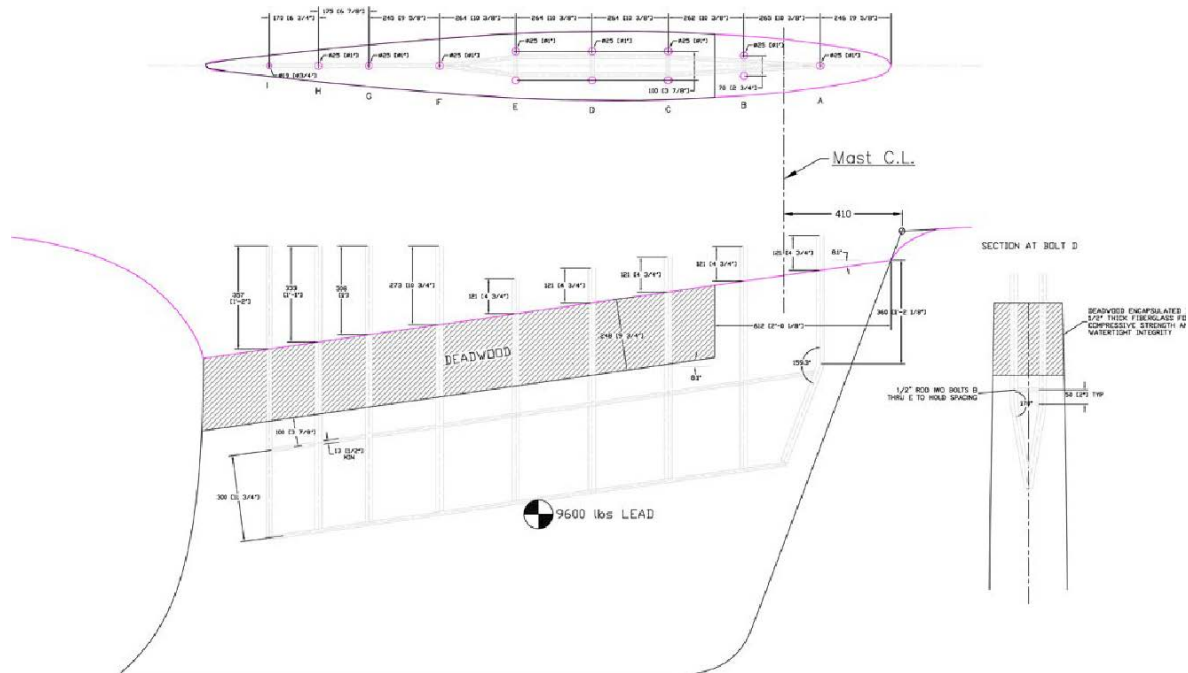
In order to maintain consistent vertical and longitudinal centers of gravity, the new keel contained an area of “deadwood” for most of the aft 2/3rds, while the forwardmost part was bolted directly to the hull for strength (Figure 3). On installation, the replacement keel fit the existing keel stub quite closely (Figure 4).

**FIGURE 3** – Design drawings of the 2005 replacement keel on *Gunga Din*

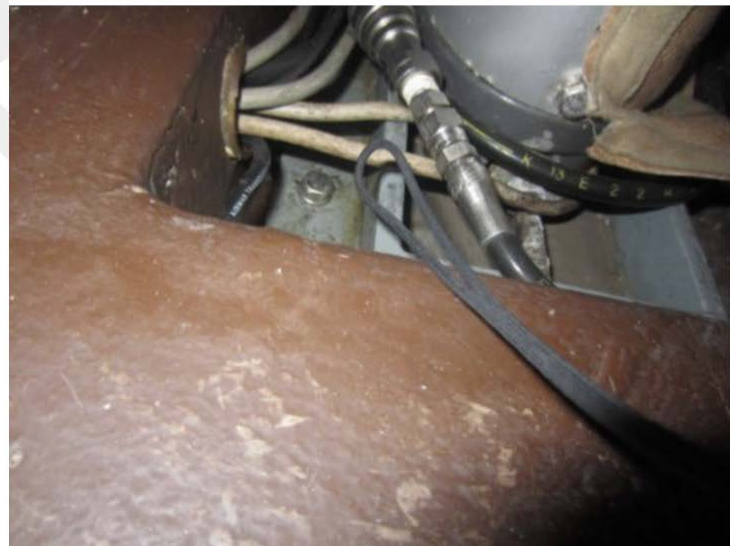
When Alec Fye located the water entering the vessel from underneath the mast step, he noted that the water appeared to be coming through a spiderweb of cracks in the bottom framing grid of the hull. As printed in Ferenc Mate’s *The World’s Best Sailboats* (1986), Sweden Yachts had adopted an integrated, molded hull bottom framing grid (Figure 5), an innovation at that time introduced by Pedrick Yacht Designs in 1979 after a request from Ericson Yachts for a more robust method to provide structural stability across the hull. According to Pedrick, this arrangement is “a molded grid of hollow, integral transverse and

**FIGURE 5** – Photo from Ferenc Mate's **The World's Best Sailboats** featuring the Sweden 41 with its innovative molded hull bottom framing grid. This photo shows a Sweden 41 under construction and shows the grid and keel root from forward looking aft. The red box indicates the location of the recess in which the mast step would later be installed. To the right is a depiction of a "hat section" and a photo of *Gunga Din's* mast step recessed in the cavity.

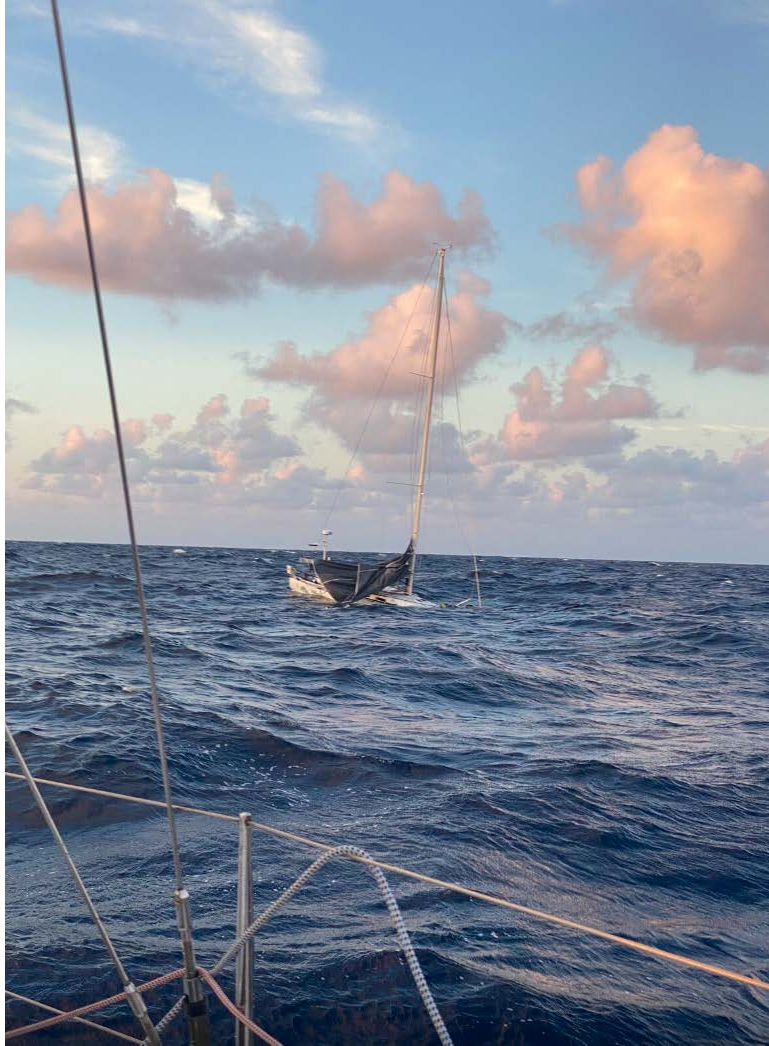
**Figure 2** The last known photograph of Alliance taken by a passing competitor shortly after dawn June 23<sup>rd</sup>.
